# THE NEGLECTED HAZARD

A GUIDE TO DROPPED OBJECT RISKS  
IN OFFSHORE WIND

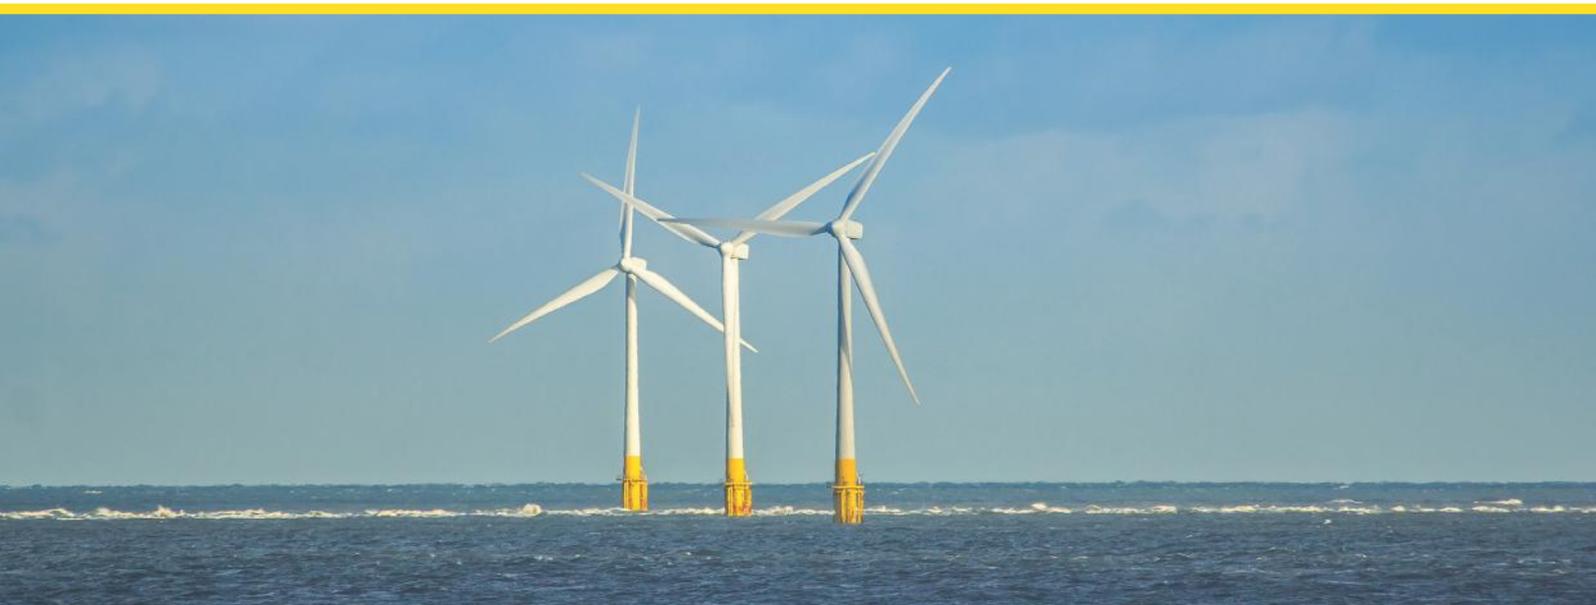
In two separate incidents, a satellite dome falls onto the deck during transit.

These incidents follow the corrosion of securing bolts and mounts, the use of unsuitable attachment systems, and corrosion within the dome itself. On both occasions, corrosion within the dome and its securing arrangement was hidden and therefore not spotted in previous visual inspections. Additionally, the location of the domes on the mast exposed them to weather and tangential g-forces.

It is easy to see an incident such as this being replicated on offshore wind vessels. Regardless of the industry, properly securing steel netting would prevent the uncontrolled fall and therefore eliminate the risk to personnel. Welding the dome pedestal to the vessel structure should also help to prevent incidents like these from happening, but it is also essential to ensure that the nuts and bolts used in the dome's attachment system are the correct size and a suitable material for the environment. Further guidance must be available for personnel carrying out visual inspections, particularly considering difficult to inspect arrangements.
